SUSQUEHANNA RIVER BASIN
BLACK MOSHANNON CREEK, CENTRE COUNTY

KEPHART DAM
NDS I.D. No. PA-00447
PENNDER I.D. No. 14-89

PHASE I INSPECTION REPORT
NATIONAL DAM INSPECTION PROGRAM

MARCH 1979

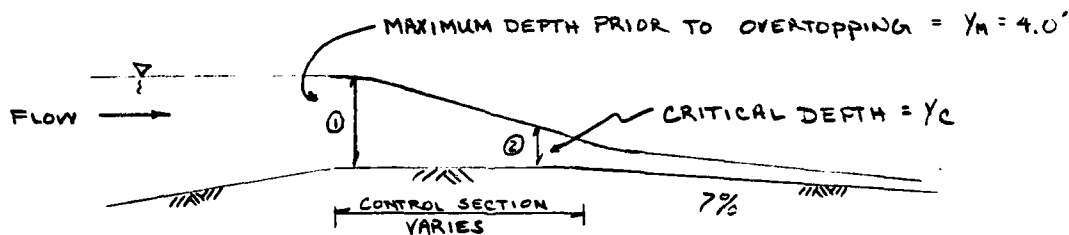
EMERGENCY SPILLWAY PROFILE
 (NOT TO SCALE)

2. Emergency Spillway. The visual inspection of the emergency spillway revealed that it was unobstructed and in good condition. The calculations indicate that the emergency spillway design was prepared based on a crest width of 40 feet. Field measurements indicate that the actual width is approximately 60 feet.

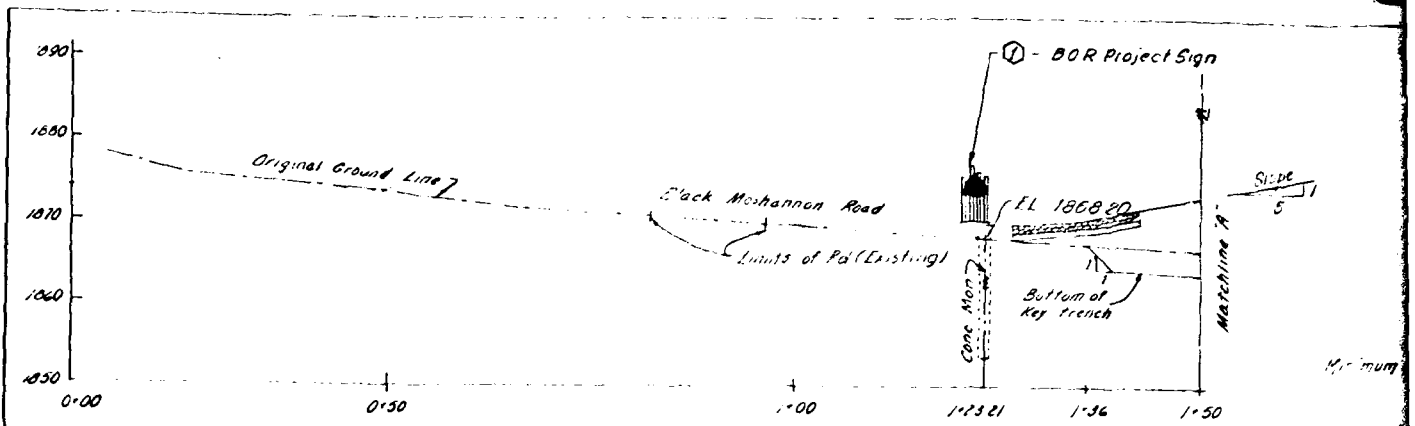
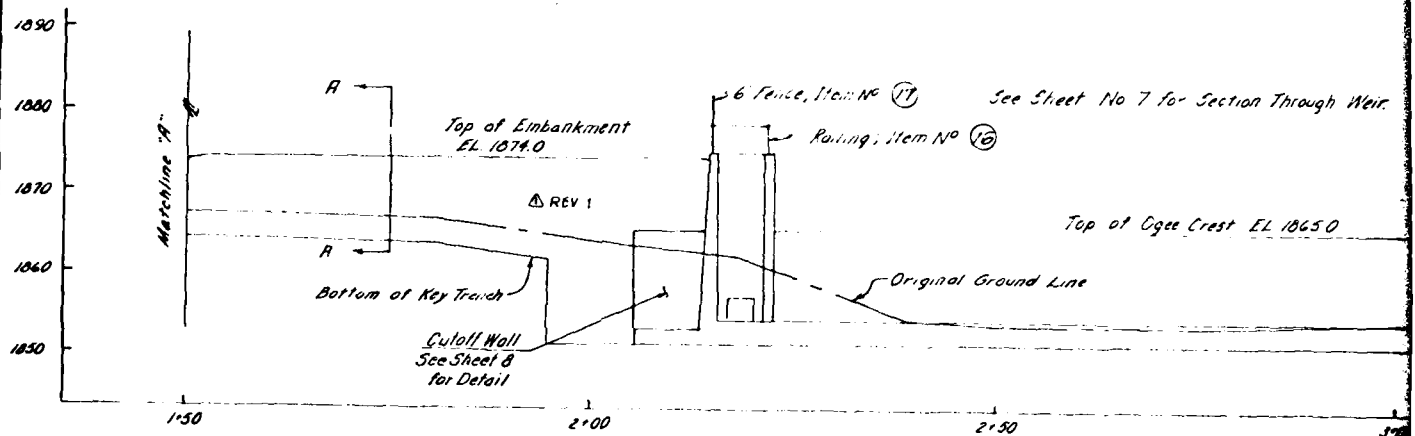
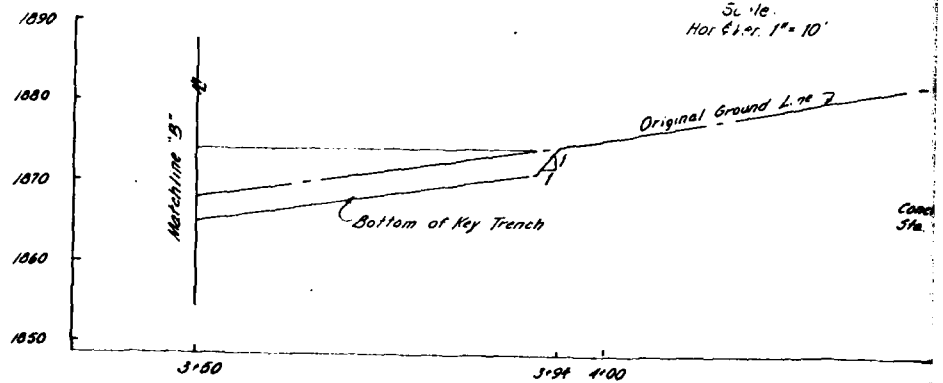
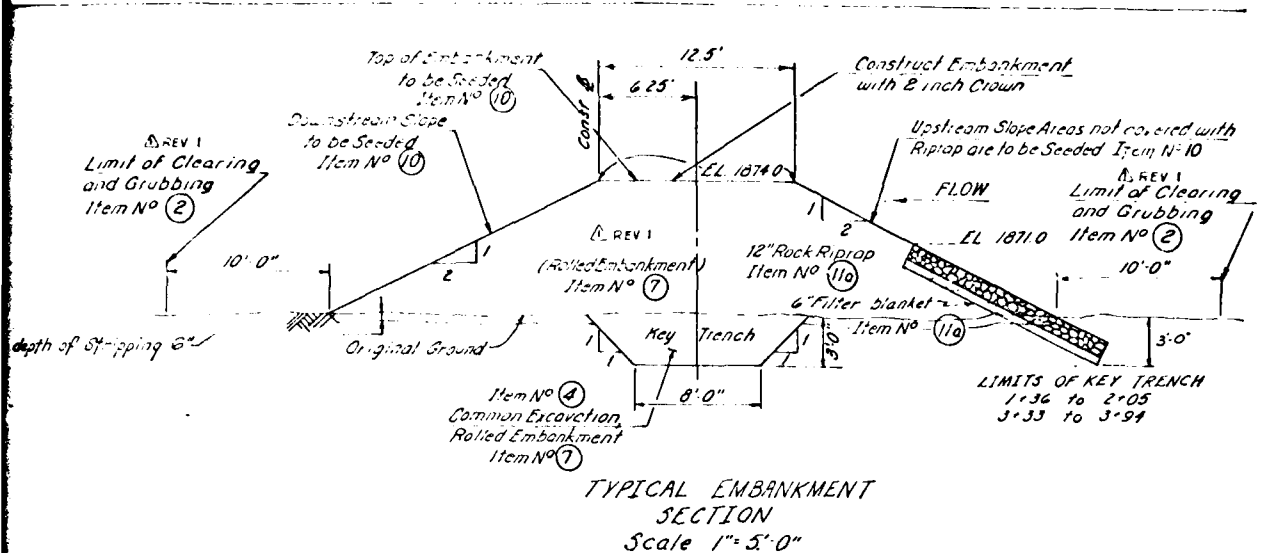
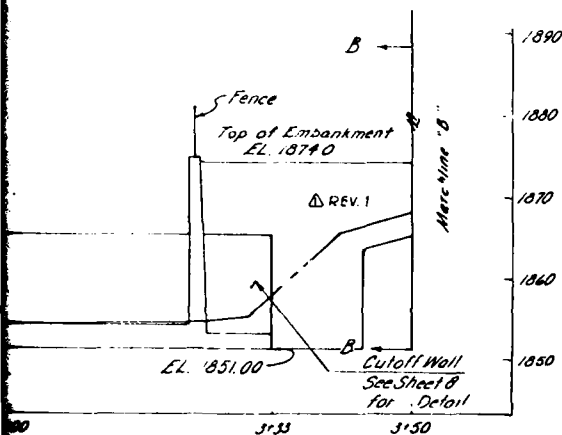
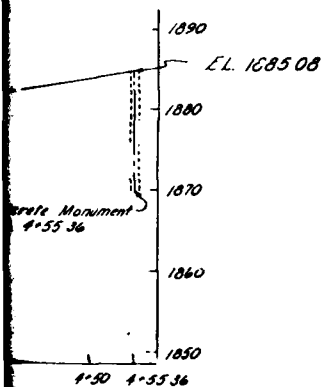
Cutoff - A cutoff trench 3 feet deep and 8 feet wide (at the base) with 1H:1V side slopes was provided between Stations 1+36 and 2+05 and from Station 3+33 to 3+94 (see Figure 4, Appendix F).

1. Embankment. Contract drawings indicate that the dam is a concrete gravity spillway structure flanked by rolled earth embankments on each end. The side slopes are 2H:1V on each face with a crest width of 12.5 feet. The embankments contain a key trench 3 feet deep and 8 feet wide at their bases with 1H:1V side slopes (see Figure 4). Riprap (12 inches thick) is provided on the upstream face to elevation 1871.
